# IFR 1500 AM/FM power supply repairs

Yves OESCH / HB9DTX, 12. January 2022

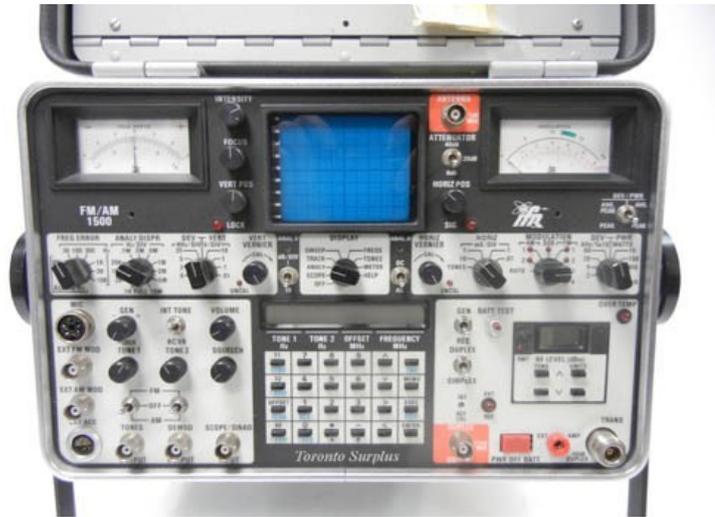
Few years ago I could save an old IFR 1550 service monitor device from the garbage can. It is used very infrequently, nevertheless, recently, it was totally impossible to switch it on. Worth mentioning, it is possible to supply the device directly with 11-16V DC. This doesn't change the problem: silent device. Only a small relay click was audible, but not other sign of life. Both fuses were OK, so the problem was located somewhere deeper...

Figure 1: IFR FM-AM 1500

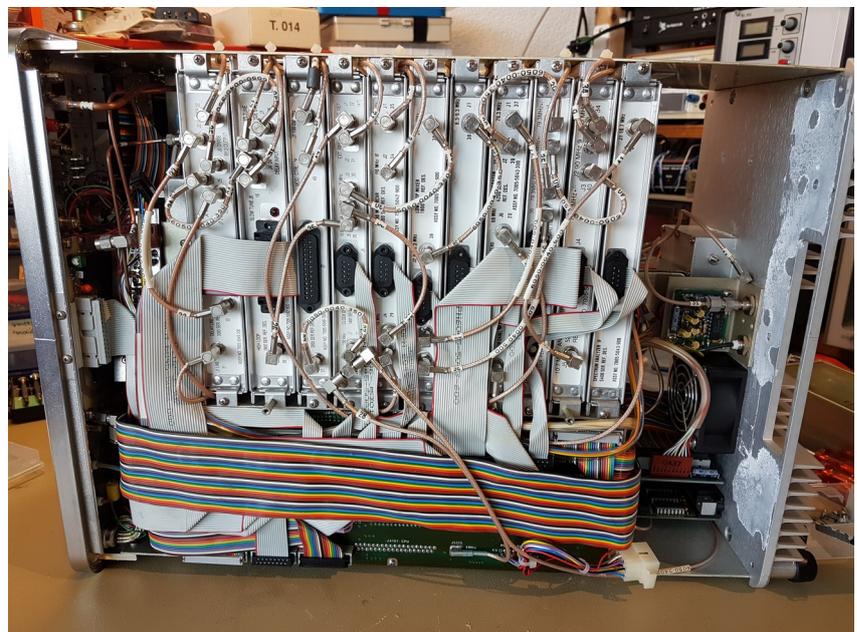
Indeed removing the power supply unit is not very complex, once one knows which screws to loosen... indeed it is sufficient to remove 3 screws from the back side, as well as the "large shielding cover" that protect the many interconnect coaxial cables on the bottom side of the device. The power supply is kind of glued to the back panel with heat-transfer compound, so some force might be applied to remove it. The 12-poles cable connector (11 of which are populated) is a bit reluctant to be disconnected, but using small flat screwdrivers both sides of the connector it is possible to loosen the anti-traction safety mechanism of the connector.

Figure 2: Internal view of the IFR-1500 (bottom side), Shielding plate, battery and power supply already removed

There might still be a bulky integrated rechargeable battery pack rated 12V / 5Ah in the device. Disconnect it as well. As the battery is probably totally dead, it is highly recommended to remove it permanently from the device to avoid possible chemicals leakage. The battery is not necessary for proper device operation. 2 long screws accessible from the back panel go all through the battery pack and maintain it in place.

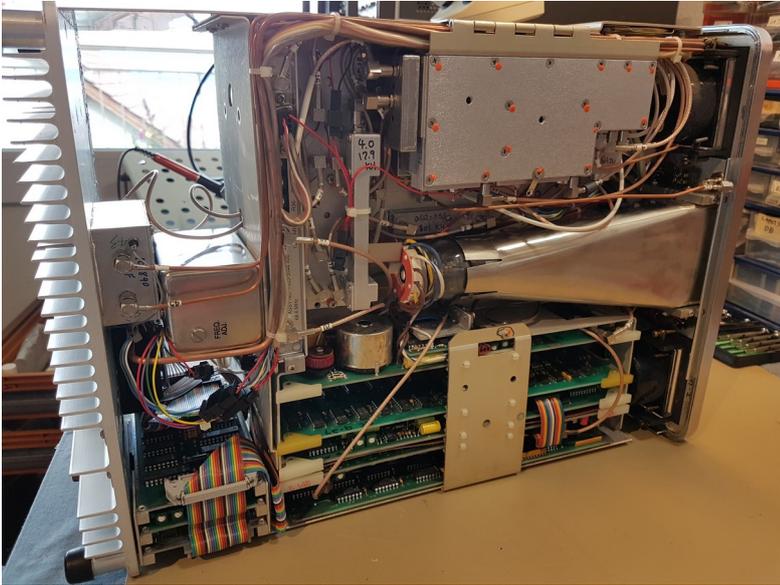
Figure 3: View of the top side of the device

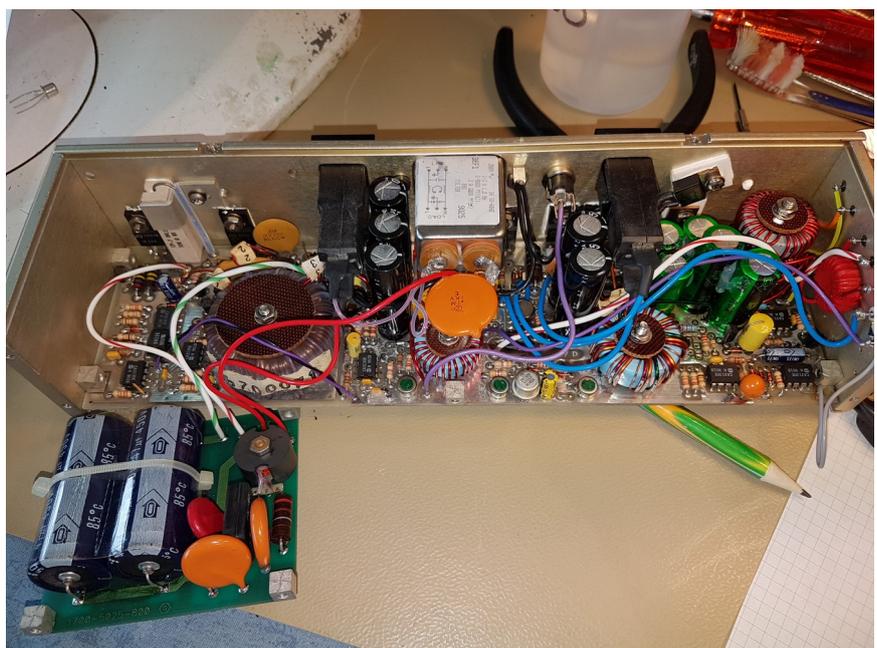
The different supplies (+5V, +12V, -12V) all come from a single multi-windings switching transformer driven by power MOS transistors cabled in parallel.

Figure 4: Power SupplyUnit (PSU) board with cover removed

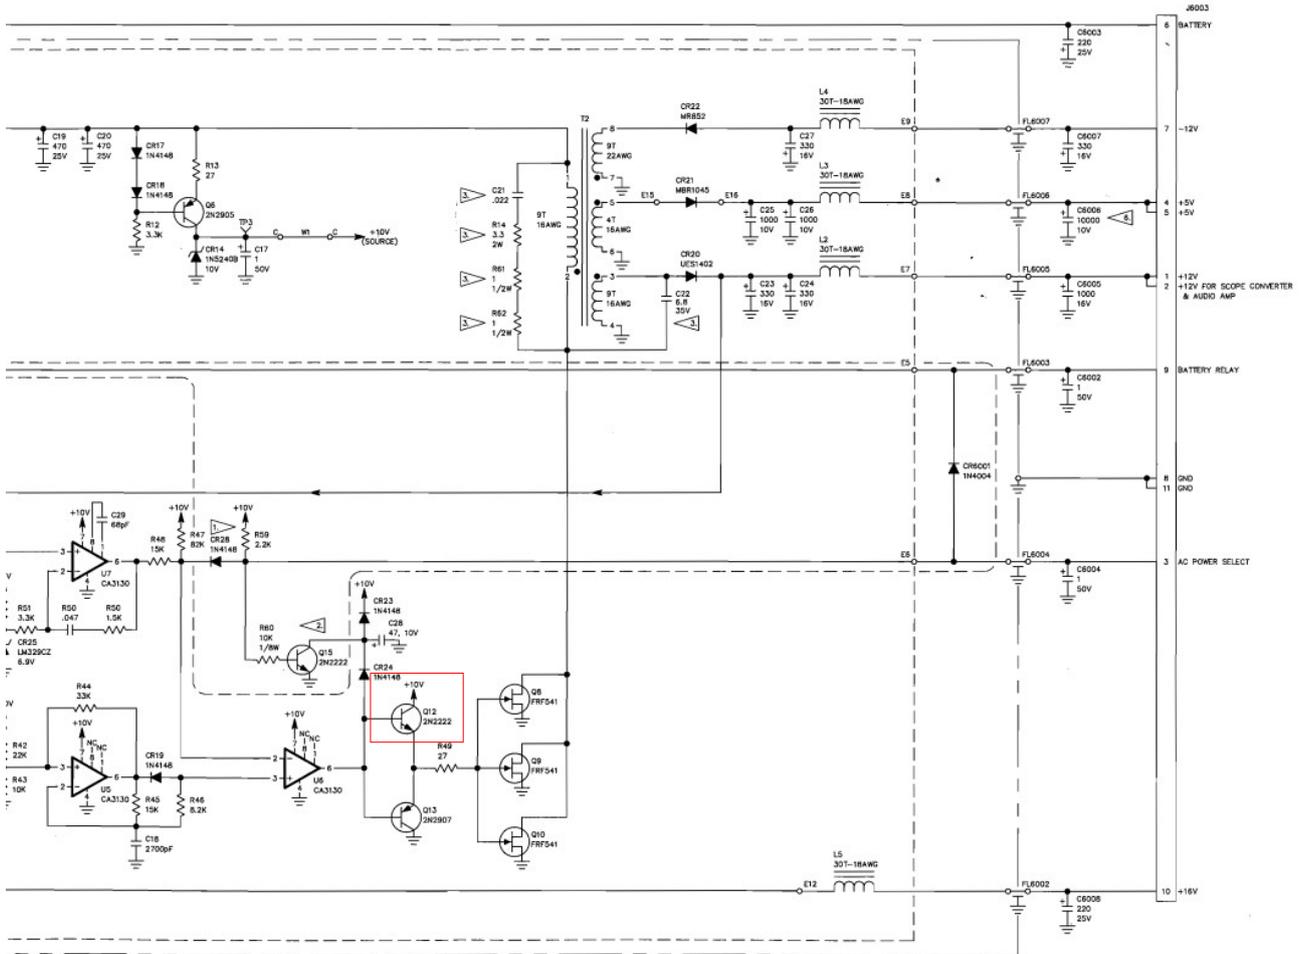
Figure 5: Extract of the power supply schematic from the service manual. In red the defective transistor.

It was quickly found that the 10 V supply rail was not present. By cutting the PCB tracks here and there the problem could be located on the NPN/PNP pair of transistors Q12/Q13 which act as driver stage. They were holding the 10V rail to a much lower value, preventing proper drive of the power-MOS.

A quick check of both NPN and PNP transistors using the “hfe” transistor test position of a suitable multi-meter showed that the NPN (original reference P2N2222) was dead (current gain was almost 0). A spare 2N2222 available in a drawer (having a different case, but still fitting on the print circuit board), was used for replacement

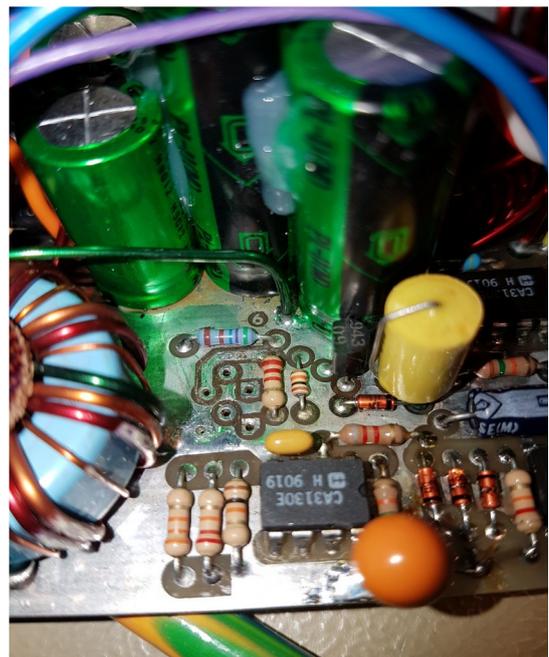
It was a bit tricky to unsolder both transistors. There was quite some oxidation on the PCB surface below those transistors. Cleanup using solder wick, isopropyl alcohol and an old toothbrush made the PCB look nice again.

Figure 6: Q12 and Q13 de-soldered, PCB cleaned

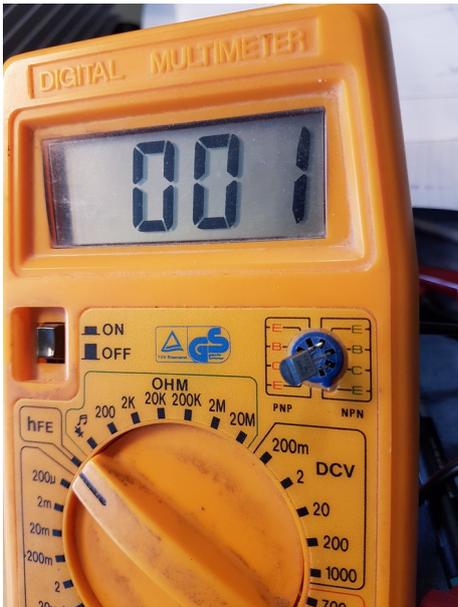
Figure 7: Defective P2N2222

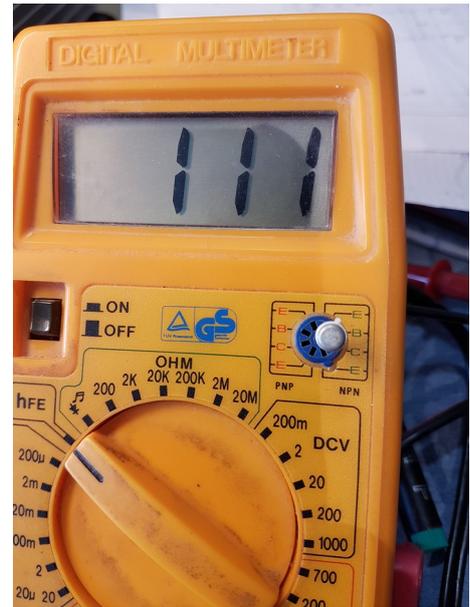
Figure 8: Replacement 2N2222

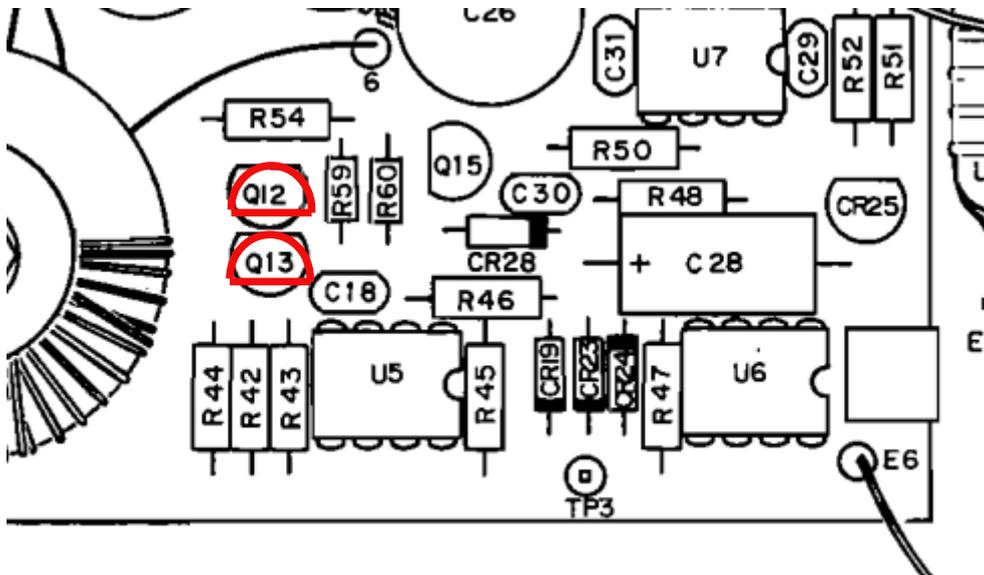
It is important to look carefully at the pinout on the PCB. There is a slight incoherence in the orientation drawing for Q12 and Q13 in the service manual. So checking which signal is physically present (10V, GND) on the actual tracks prevented any error when soldering the replacement device.

Figure 9: Component placement on the PSU board, showing wrongly oriented Q12 and Q13 (correct orientation in RED)

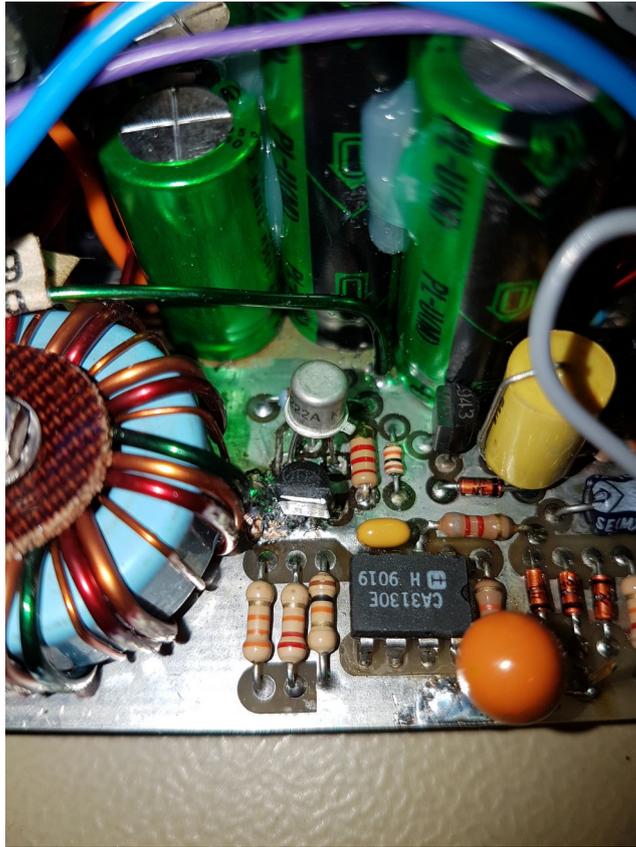
*Figure 10: New 2N2222 transistor in place*

Once soldered, a check of the PSU showed all the needed supplies present.

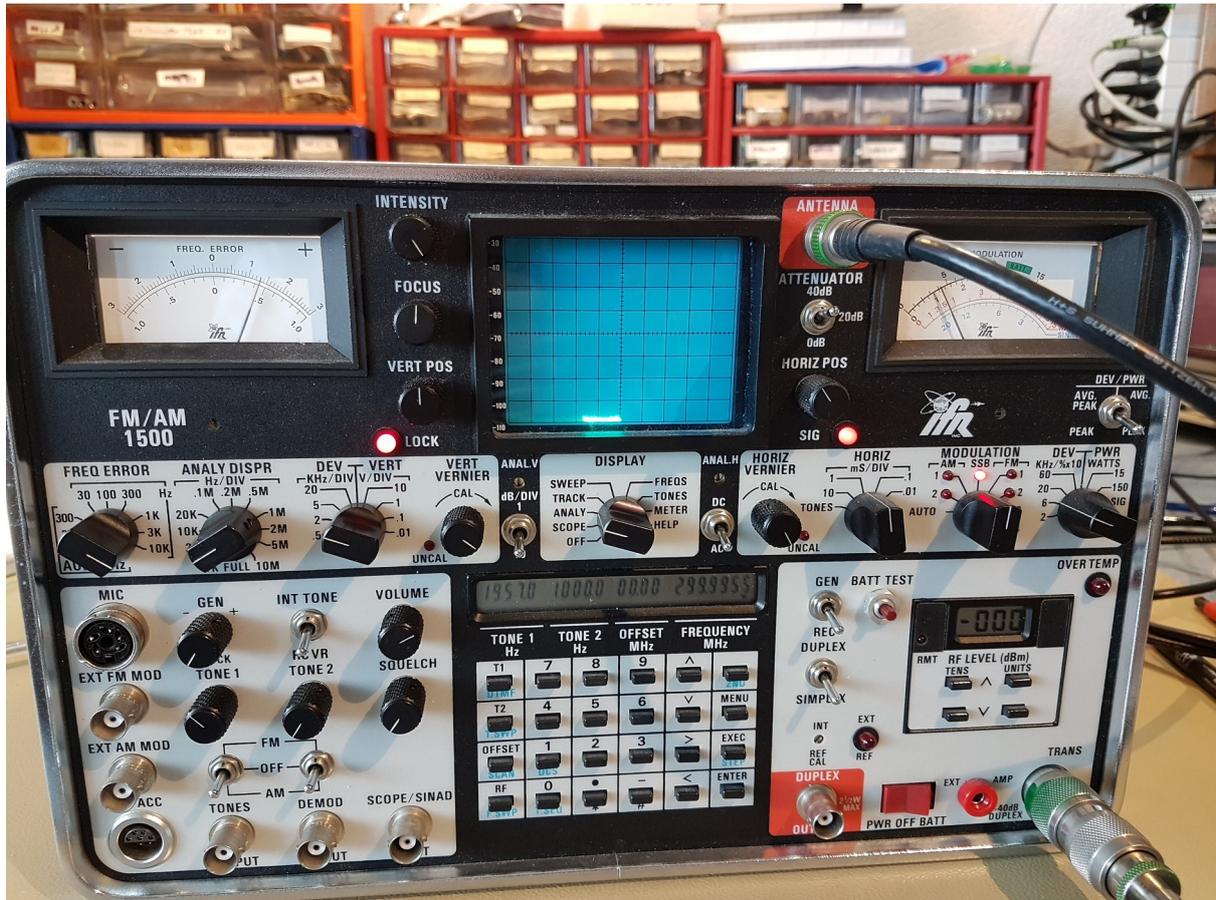
Figure 11: IFR AM-FM 1500 after repairs of its power supply unit. (The fast camera aperture speed makes the spectrum analyzer display look defective, but it is not the case in reality !)

It was also noticed that the 7.5 A fuse tend to trip easily and got extremely hot. Indeed the current flow measured on the 13V DC supply easily goes above 8A for several tens of seconds at startup, and stabilized slightly below 7A. In this sense it is recommended to use a fuse allowing at lest 10A to pass (trials with 8A were unsuccessful)
